NATIONAL TRANSPORTATION SAFETY BOARD

ON-SCENE and EXAMINATION INFORMATION

**NTSB Accident: WPR17FA013
Accident Date: October 25, 2016**

Location: Pittsburg, California
Date: October 25, 2016
Aircraft: Beechcraft A36 'Bonanza', N364RM, Serial # E-2957
NTSB IIC: Michael Huhn

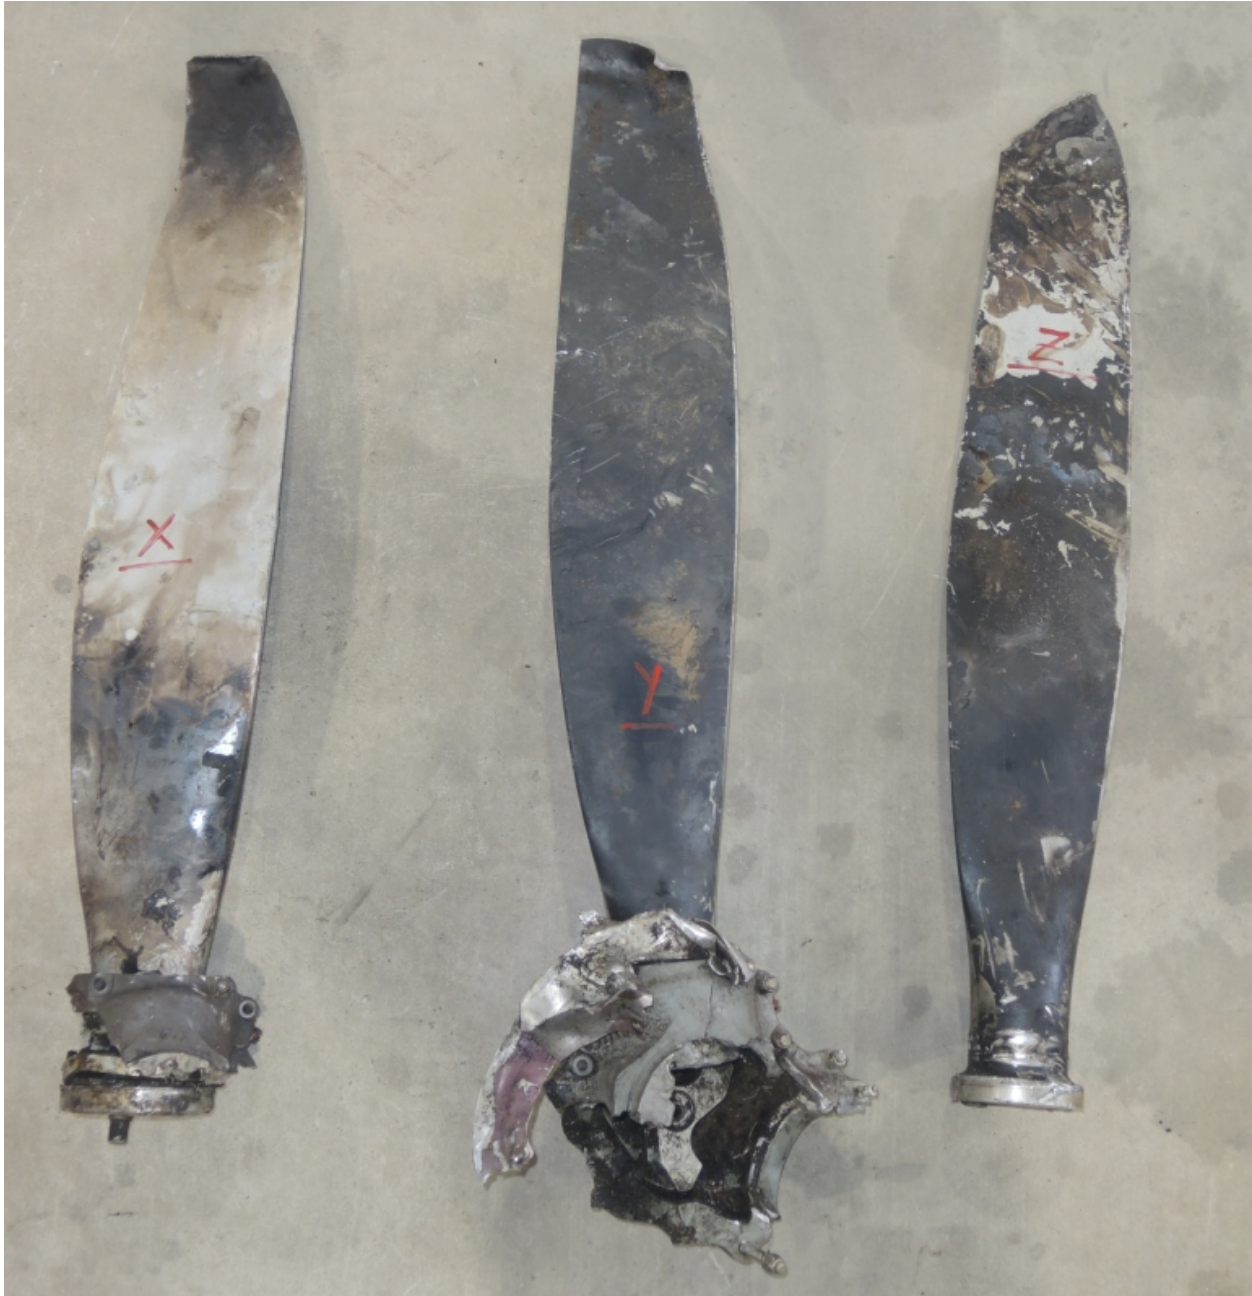
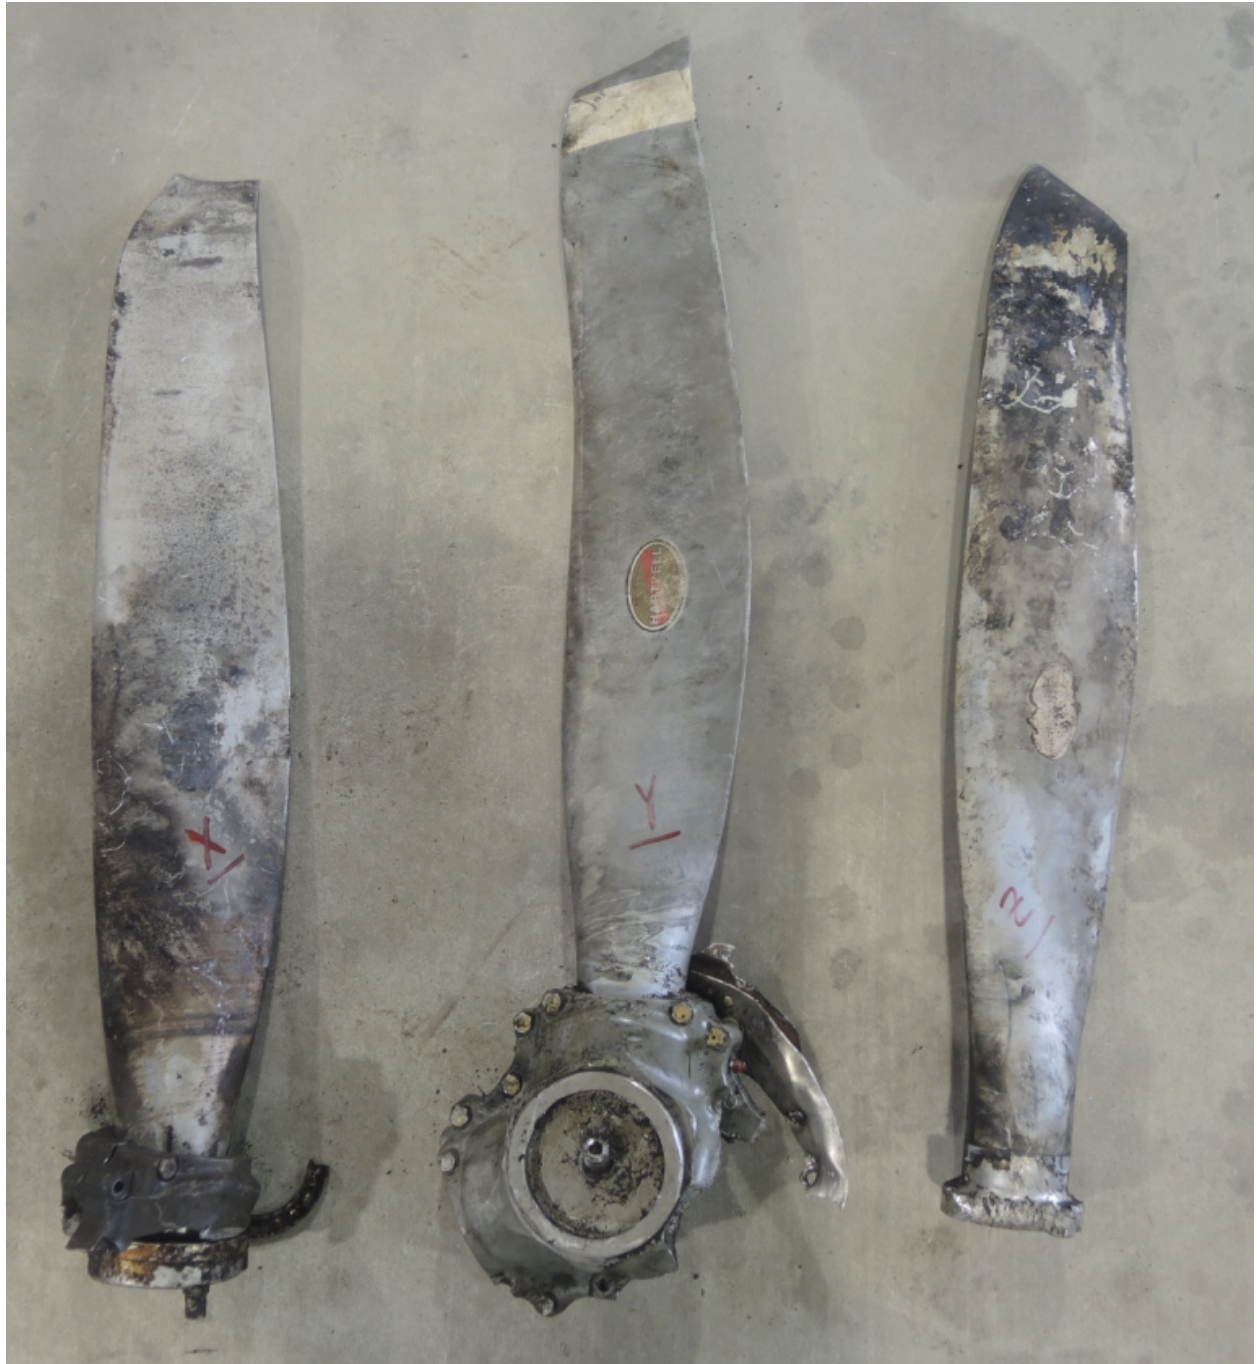
- The airplane was equipped with a Hartzell model PHC-C3YF-1RF three-blade, all-metal propeller
- All three blades were recovered at the main wreckage site
 - Two were in close proximity to one another, near the 'bottom' layer of main wreckage debris
 - One was found in the bottom of the ravine, about 15 feet from the other two
- Two blades were fracture-separated from the propeller hub, which was fractured into numerous pieces
- All three blades were missing about $\frac{3}{4}$ " to 1-1/2" from their tips; those three tips were never identified in the wreckage
- All three blades displayed relatively minimal shape deformation
- During recovery, a distinct paint-transfer of the black and white paint from one propeller blade was observed imprinted on the compressed soil of the accident site
- No evidence of any pre-impact failure of the propeller or its components and controls was observed

Figure 36 - Propeller Blades and Hub Fragment

Figure 37 - Propeller Blades and Hub Fragment

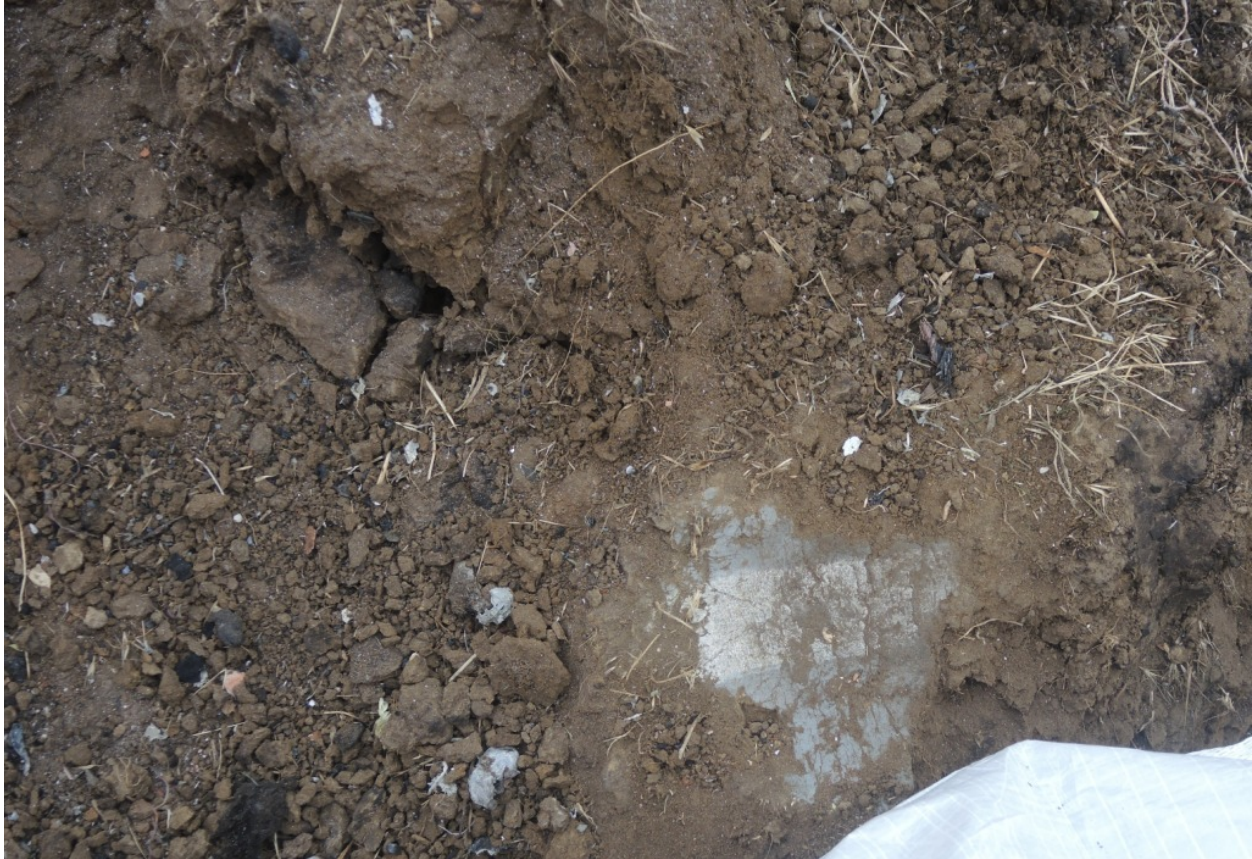
Figure 38 - Propeller Blade Paint Transfer

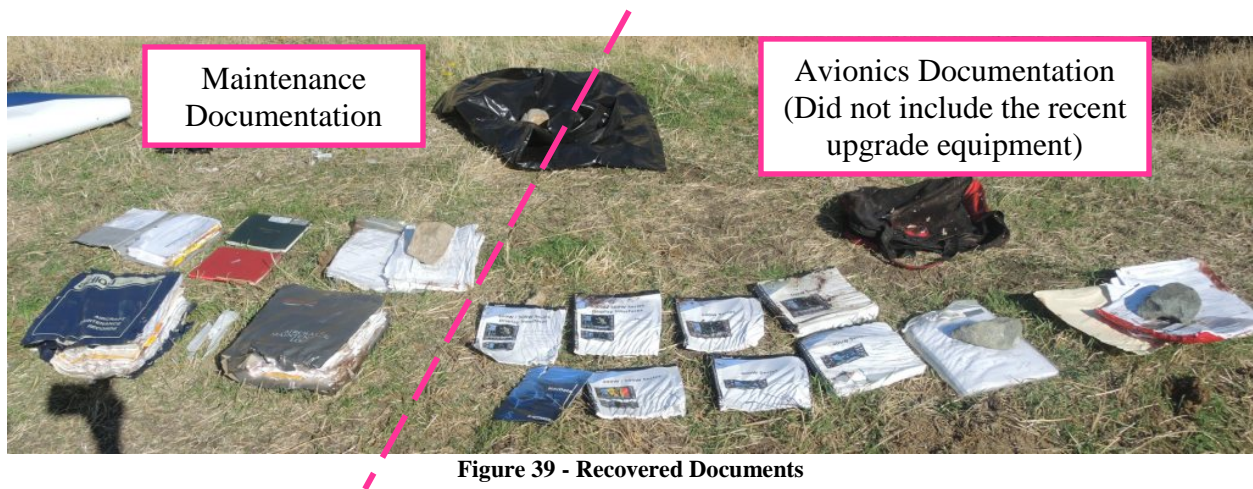
- The documents were impact- and water-damaged, but generally intact
- No pilot logs were observed in the wreckage
- A large quantity of maintenance records was on board the airplane at the time of the accident; and survived in relatively good condition

Figure 39 - Recovered Documents
